Case 344 : Narrative

| Case Vehicle (A): 2000 Chevrolet | Vehicle (B): 2001 Mercury |
| Type: Tahoe LS, 4-door SUV with trailer | Type: Sable LS, 4-door sedan |

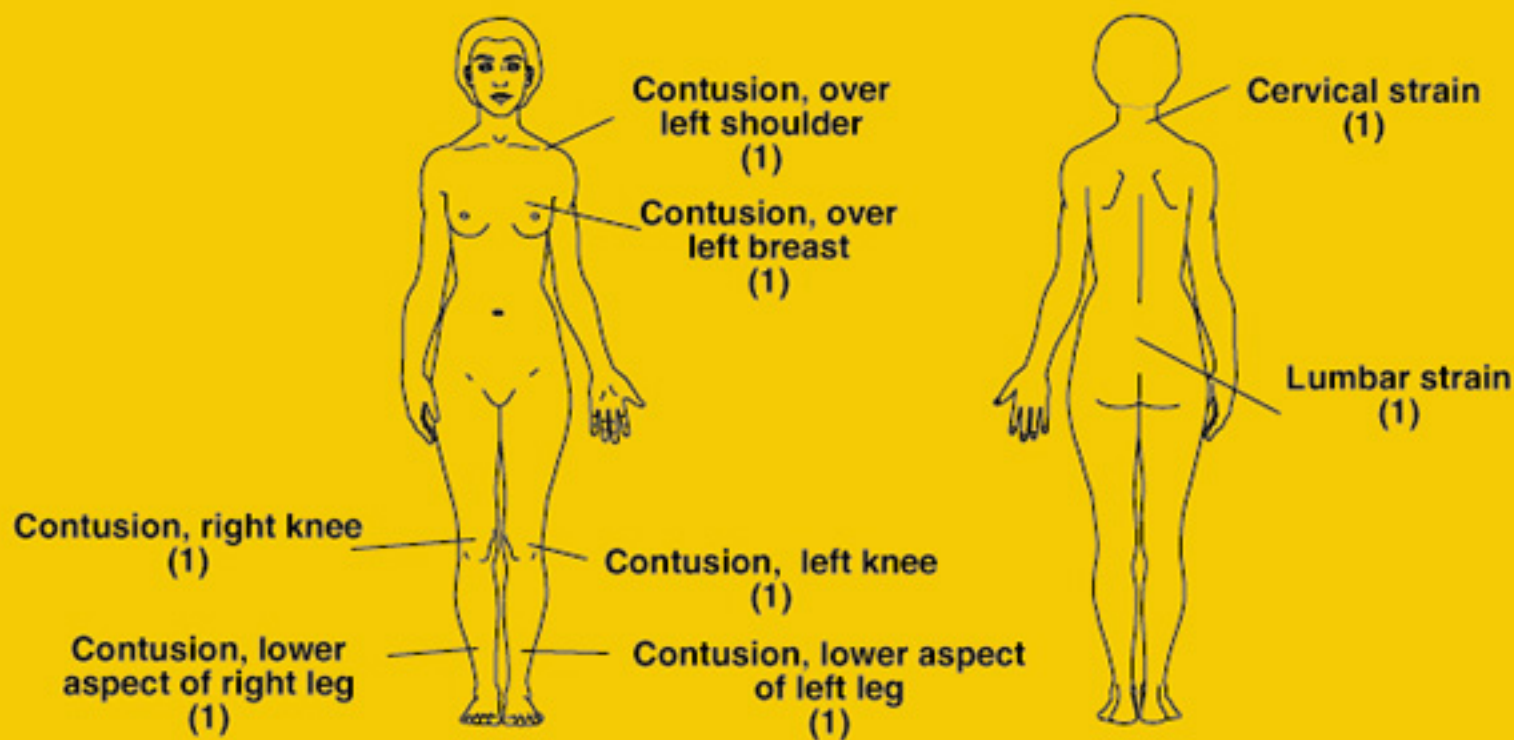
CASE NO.: 344-02

The following table [56](#) and attached drawing summarize the injuries for the belt-and-airbag restrained driver.

| Occupant: Driver | Age: 29 years | Gender: Female | | |
|---|---|---|---|---|
| Cervical strain | 1 | Impact forces | — | — |
| Contusion, over left shoulder | 1 | Shoulder belt | — | — |
| Contusion, over left breast | 1 | Shoulder belt | — | — |
| Lumbar strain | 1 | Impact forces | — | — |
| Contusion, left knee | 1 | Knee bolster | — | — |
| Contusion, right knee | 1 | Knee bolster | — | — |
| Contusion, lower aspect of left leg | 1 | — | Brake pedal | — |
| Contusion, lower aspect of right leg | 1 | — | Accelerator pedal | — |

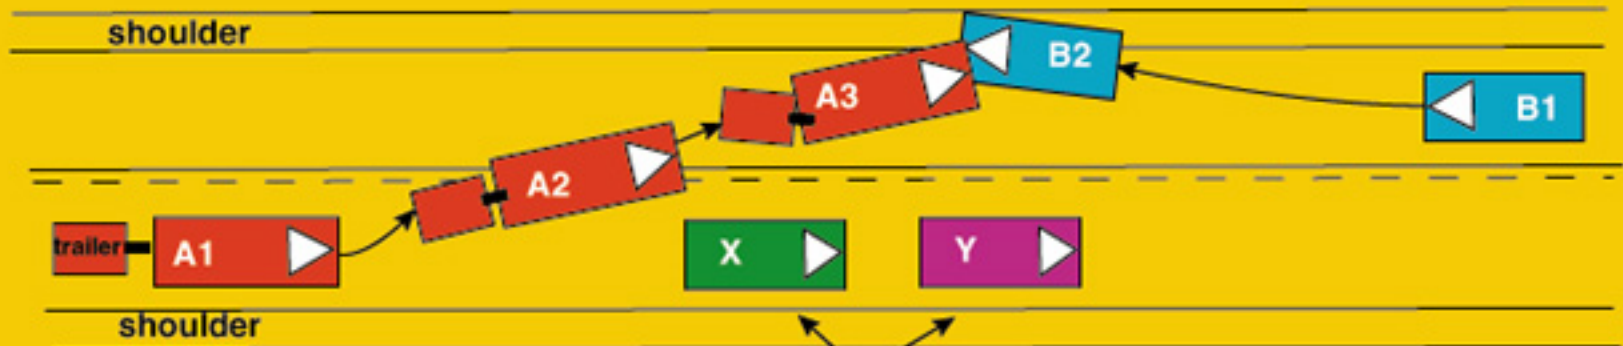
vehicles (X) and (Y)
stopped abruptly for
an animal in the road
